A Sacrificial Anode Retrofit Program for Existing Cast Iron Distribution Water Mains

JEFF SCHRAMUK, *NACE Cathodic Protection Specialist*
DANNY J. KLOPPER, *Des Moines Water Works*

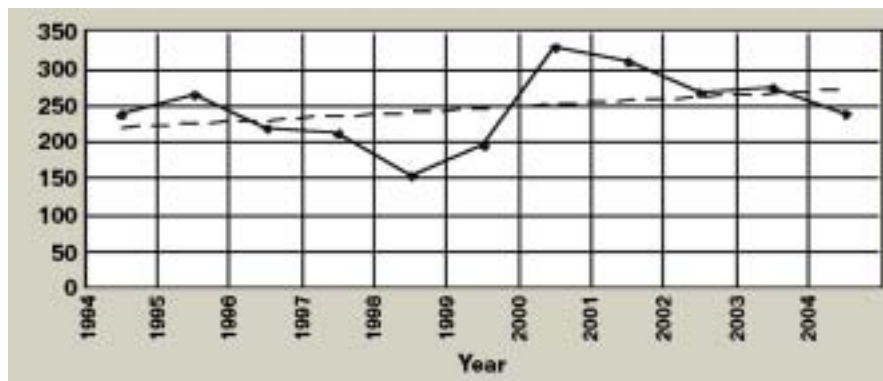
FIGURE 1

Total main breaks per year.

The Des Moines (Iowa) Water Works (DMWW) currently is responsible for maintaining 1,013 miles (1,630 km) of water distribution piping. Current water main break rates are now at ~27 breaks per 100 miles (161 km) of pipe. The trend in main breaks from 1988 to the present time has shown a steady increase in failure rates (Figure 1). Most of the water main breaks in the distribution system are either directly or indirectly related to corrosion, excluding third-party excavation damage to the pipe.

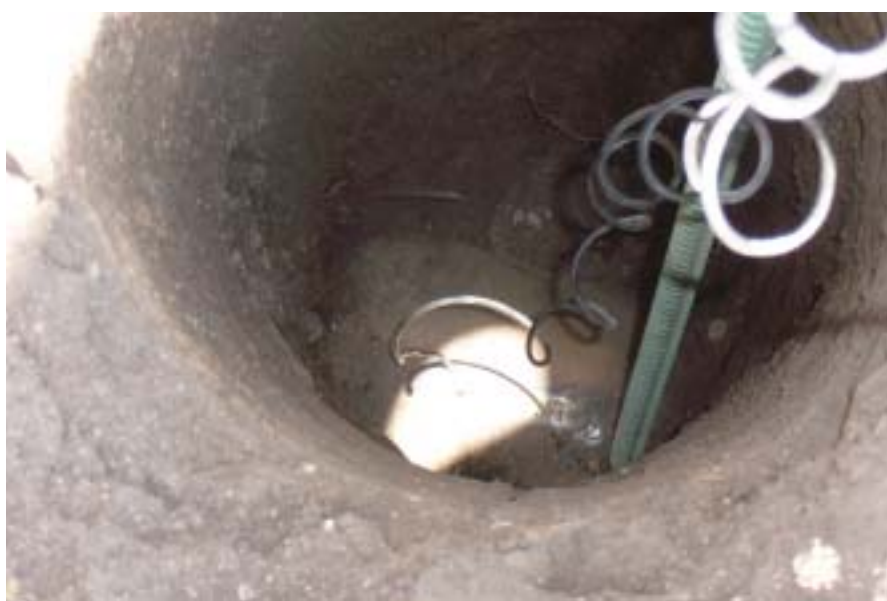
FIGURE 2

Steel stud arc welded to the top of the pipe.

The anode borehole is initiated by a backhoe-augur that drills through the pavement or surface soils down to ~12 in. (0.3 m) above the pipe. To avoid damage to the buried waterline, the method then utilizes vacuum extraction equipment to remove the remaining soil in the hole down to the top of the buried pipe. Once the top of the pipe is exposed and cleaned, a carbon steel stud is arc-welded to the top of the pipe (Figure 2). The arc welder is run from a portable field generator.

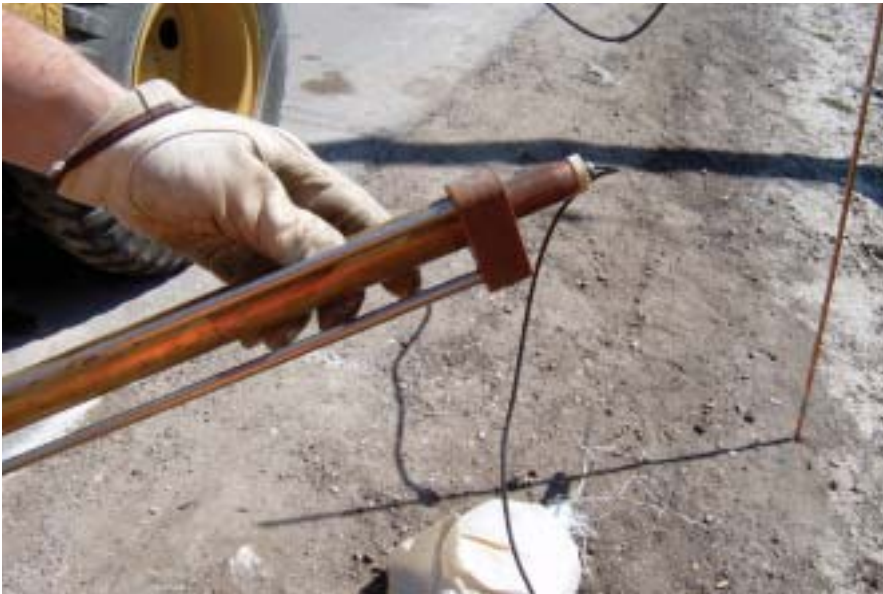
FIGURE 3

Stud fits in the end of the extension tool.

A special insulated extension tool was fabricated to allow the welder to reach to the top of the pipe and contact the pipe surface. The stud is silver-soldered to each anode's #12 AWG lead wire, and the stud fits snugly into a tapered copper sleeve in the end of the extension tool (Figure 3). The extension tool is connected to the welder's trigger handle by high-capacity insulated cables. A steel rebar is used to make the ground connection between the pipe and the welder, also using an insulated cable. When electrical continuity is verified between the stud and the rebar ground, the operator initiates the welder by pushing a button in the trigger handle.

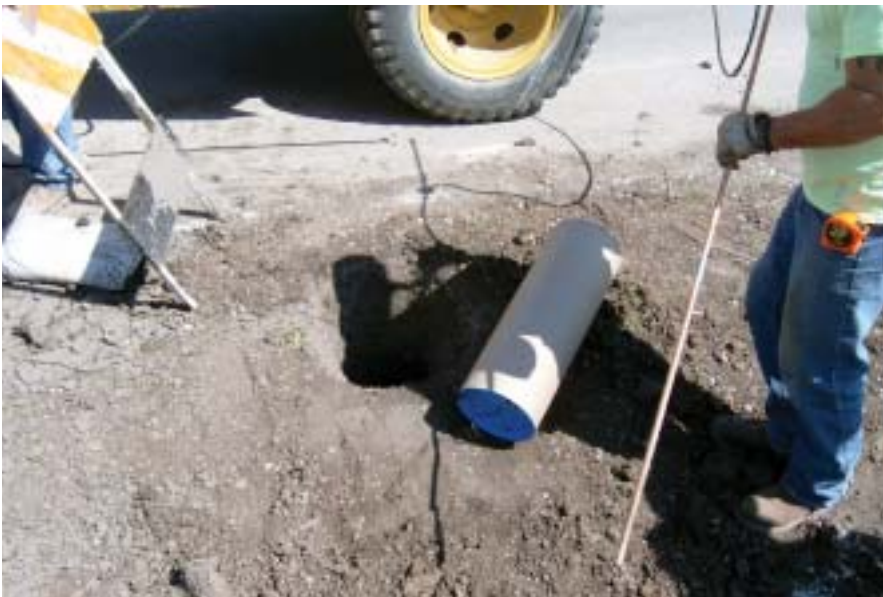
FIGURE 4

Prepackaged sacrificial anode is lowered down into the hole.

After the stud weld is verified to be secure, the prepackaged sacrificial anode is lowered down into the hole (Figure 4). To achieve the greatest life, a 32-lb (14.55-kg) high-potential magnesium anode was specified for all installations. A 6- to 12-in. (152- to 305-mm) layer of sand/limestone fines is poured into the hole over the weld to ensure that the an-

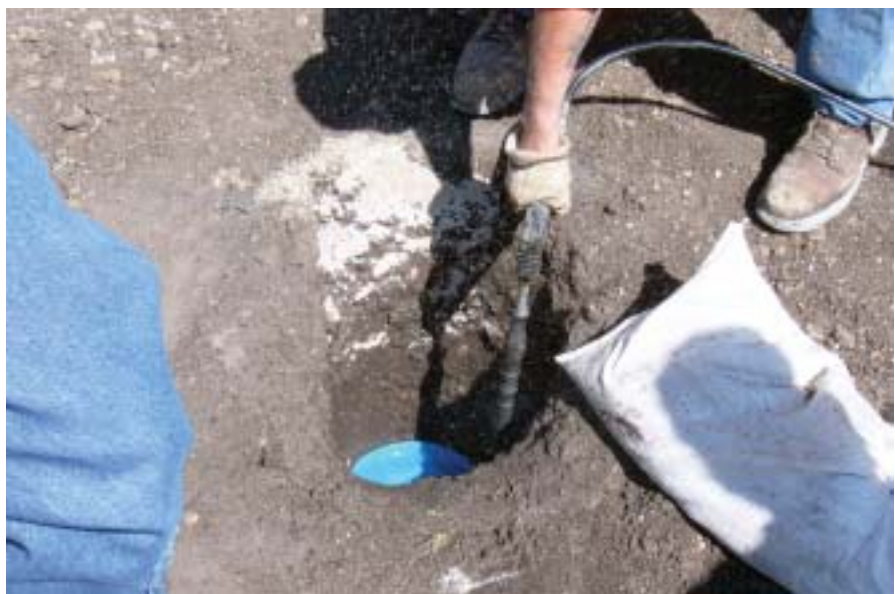
FIGURE 5

Anode is backfilled with limestone fines, native soil, and water.

ode does not rest directly upon the stud. Although the paperboard anode canister is filled with a low-resistance, hygroscopic material, ~5 gal (19 L) of water is poured into the hole to ensure maximum anode current flow to the pipe (Figure 5). Compacted native soil fills the balance of the hole. Pavement restoration or turf replacements complete the installation.
